Investigation of relationship between microstructure and tensile properties in hydrogen environment using Cr-Mo steels

Hiroshi Okano*, Shusaku Takagi, Akihide Nagao, Nobuyuki Ishikawa

Steel Research Laboratory, JFE Steel Corporation
1-1, Minamiwatarida-cho, Kawasaki-ku, Kawasaki, 210-0855, Japan

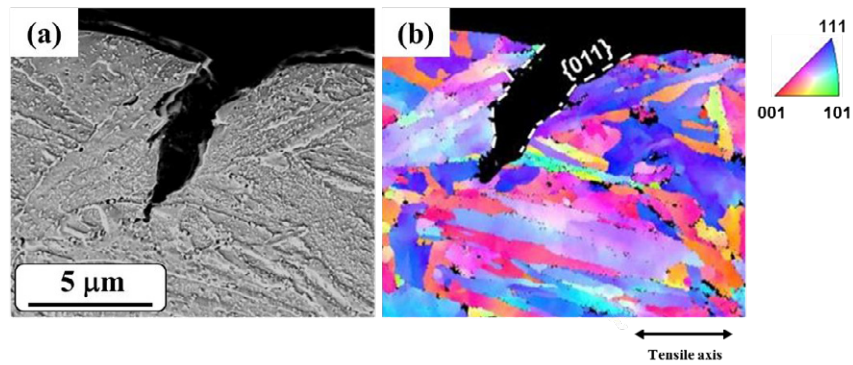
Fig.2 (a) SEM image and (b) corresponding EBSD orientation map of an area in the vicinity of a surface crack generated in the presence of hydrogen in a hydrogen charging specimen.

The SSRT results show that both total elongation and reduction in area decreased in the presence of hydrogen. The reduction in area was 69.3% in the atmospheric environment and 59.6% with hydrogen charging. Fig. 1 shows the fracture surfaces obtained by SSRT in air and with hydrogen charging. In air, a dimple fracture surface was observed overall. With hydrogen charging, a fragile fracture surface (quasi-cleavage) was observed around the side surface of the specimen. Numerous surface cracks were observed on the specimen surface in the SSRT test conducted simultaneously with hydrogen charging, while such surface cracks were not found on the specimen tested in air. Fig. 2 shows the results of SEM and EBSD analysis at the depth of 8 μm from the side surface around a surface crack. Propagation of the surface crack propagated into the specimen center was confirmed. An orientation analysis revealed that the surface crack path consisted of $\{011\}$ facets. These results are agreement with the results of previous studies [7-8].

(2) An orientation analysis revealed that the surface crack path consisted of {011} facets.

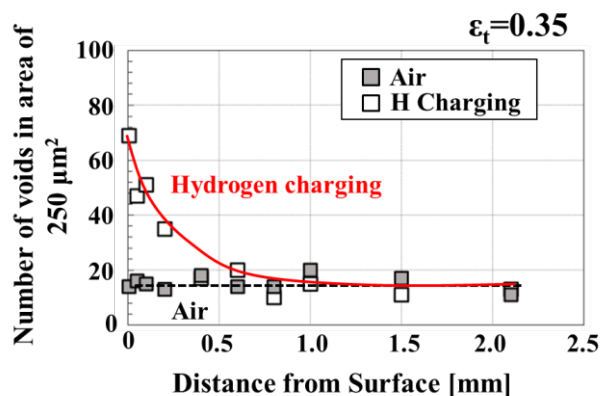
Fig. 4 Relationship between area density of microvoids and distance from specimen surface at $\epsilon_t=0.35$ of the tensile specimens.

Fig. 4 shows the microvoid area density with respect to distance from the specimen surface. In air, the microvoid area density at the specimen surface was almost the same as that in the central part. In contrast, with hydrogen charging, a larger number of microvoids were found around the surface than in the central part. These results indicated that hydrogen enhanced the formation

(5) In air, the microvoid area density in the vicinity of the specimen surface was almost the same as that in the central part of the specimen. On the other hand, with hydrogen charging, a larger number of microvoids were found around the surface than in the central part.
